Miller-Home Inspections

Report: [M-01031511 sample](#)

Confidential Inspection Report

[1230 Any Street](#)

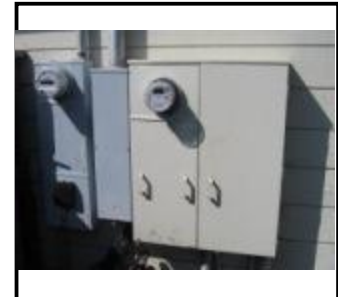
Location: Service entrance is overhead, with the main panel located at, right side of garage. S.

Sub panel: 200 amp. in basement

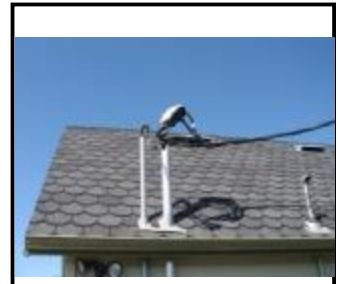
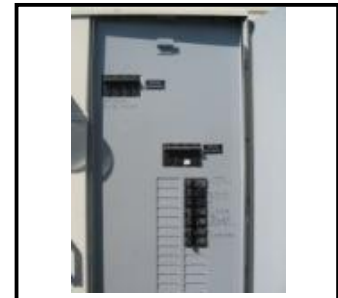
Conductors: Predominate wiring material where visible is copper.

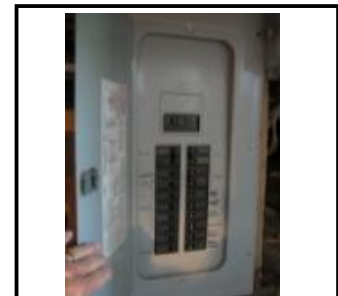
Grounding Method: Grounding method, copper wire attached to UFER Rebar extending from concrete slab, copper water pipe and gas line pipe. S.

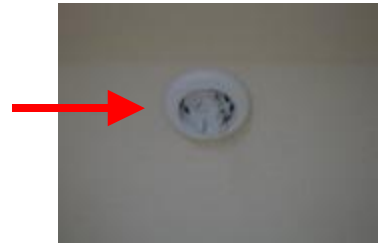
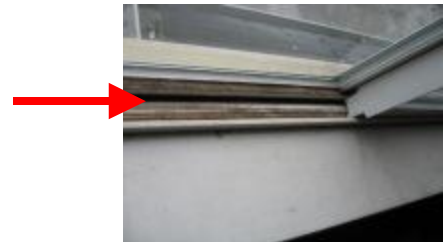
1610 Location: left
1611 Floor: Laminate plank
1612 Walls: S
1613 Ceilings: S
1614 Doors: ok
1615 Windows: S *tracks need cleaning.*
1616 Screens: S
1617 Electrical: S *smoke detector missing at ceiling.*
1618 Closets/Wardrobe: S

1619 Comments: *Some areas not visible due to owners furnishings and articles.
Overall room in good shape minor repairs.*

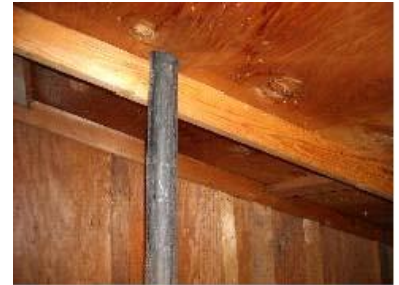
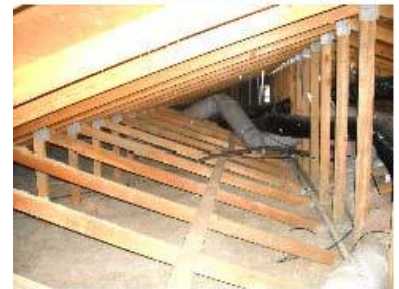
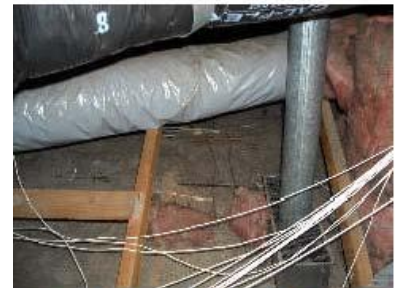
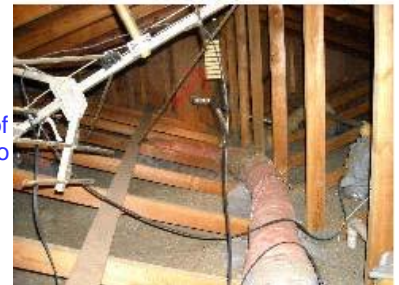
1758 Ducting: Insulation or vapor barrier covering on ducting is torn or missing and should be taped or repairs made to maintain energy efficiency.

1759 Comments: . Exhaust vents were terminating correctly, exhausts through the roof ok. All normal conditions. Additional foil coated insulation could improve R values. No leaks or moisture penetration visible.
